RE: Asbestos Inspection Report
City of Richmond
Former Fulton Gas Works
Building #1
Peebles Street
Richmond, Virginia
FEI Project Number: FEI-16AL243

RE: Asbestos Inspection Report
City of Richmond
Former Fulton Gas Works
Building #2
Peebles Street
Richmond, Virginia
FEI Project Number: FEI-16AL243

RE: Asbestos Inspection Report
City of Richmond
Former Fulton Gas Works
Building #3
Peebles Street
Richmond, Virginia
FEI Project Number: FEI-16AL243

RE: Asbestos Inspection Report
City of Richmond
Former Fulton Gas Works
Sheds #2 and #3
Peebles Street
Richmond, Virginia
FEI Project Number: FEI-16AL243

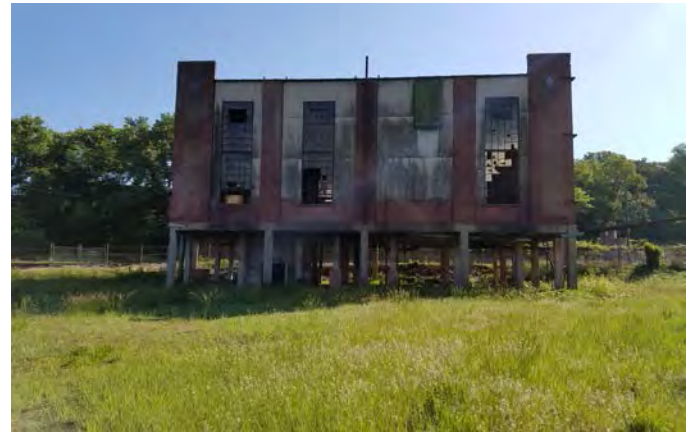
View of Building #2

Note: Suspect damaged ACM debris in poor condition was observed throughout the floor of Building #2 that should be treated as ACM.

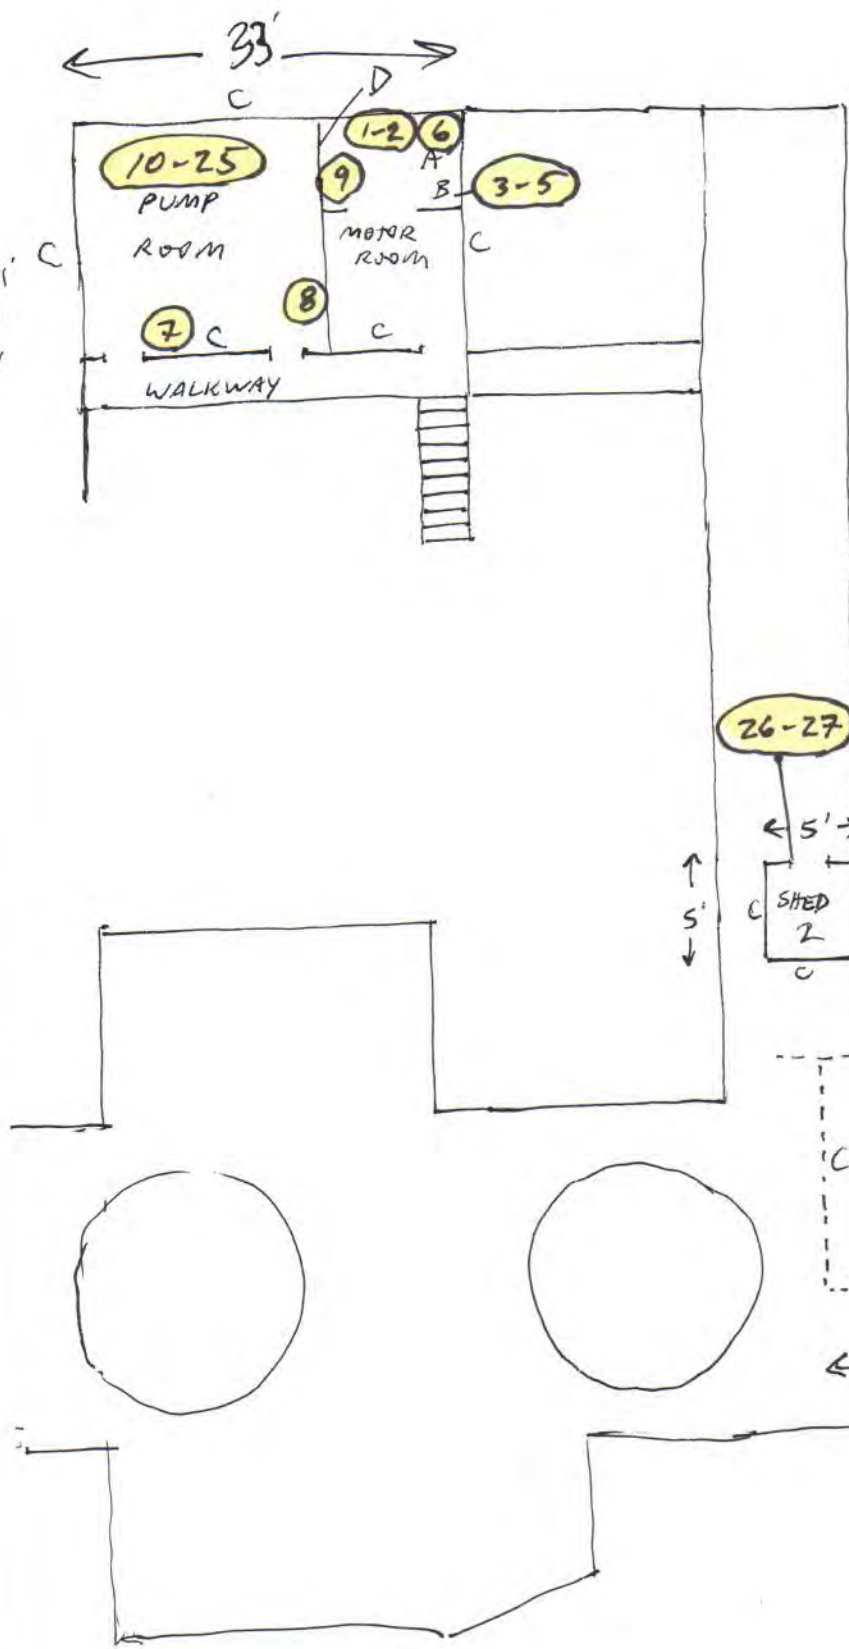
ASBESTOS SAMPLE LOCATIONS

- 1,2 A) BLACK/BROWN GASKET MATERIAL FAIR
- 3,4,5 B) WHITE FRIABLE ROPE GASKET
- 6,7 C) 20 LF POOR GRAY TRANSITE PANELS ROOF, WAHS
- 8,9,10 D) WHITE/GRAY WAH MUD POOR
- 11,12,13 E) WHITE 4" O.D. TSI (YELLOW) POOR
- 14,15,16 F) 30 LF POOR WHITE 6" O.D. TSI (ORANGE)
- 17,18,19 G) 50 LF POOR WHITE 12" O.D. TSI (ORANGE)
- 20,21,22 H) 30 LF POOR WHITE TANK INSULATION (ORANGE)
- 23,24,25 I) 3 TANKS - 75 SF WHITE 3" TSI (SILVER)
- 26,27 J) 50 LF POOR WHITE EXTERIOR DOOR CAULK

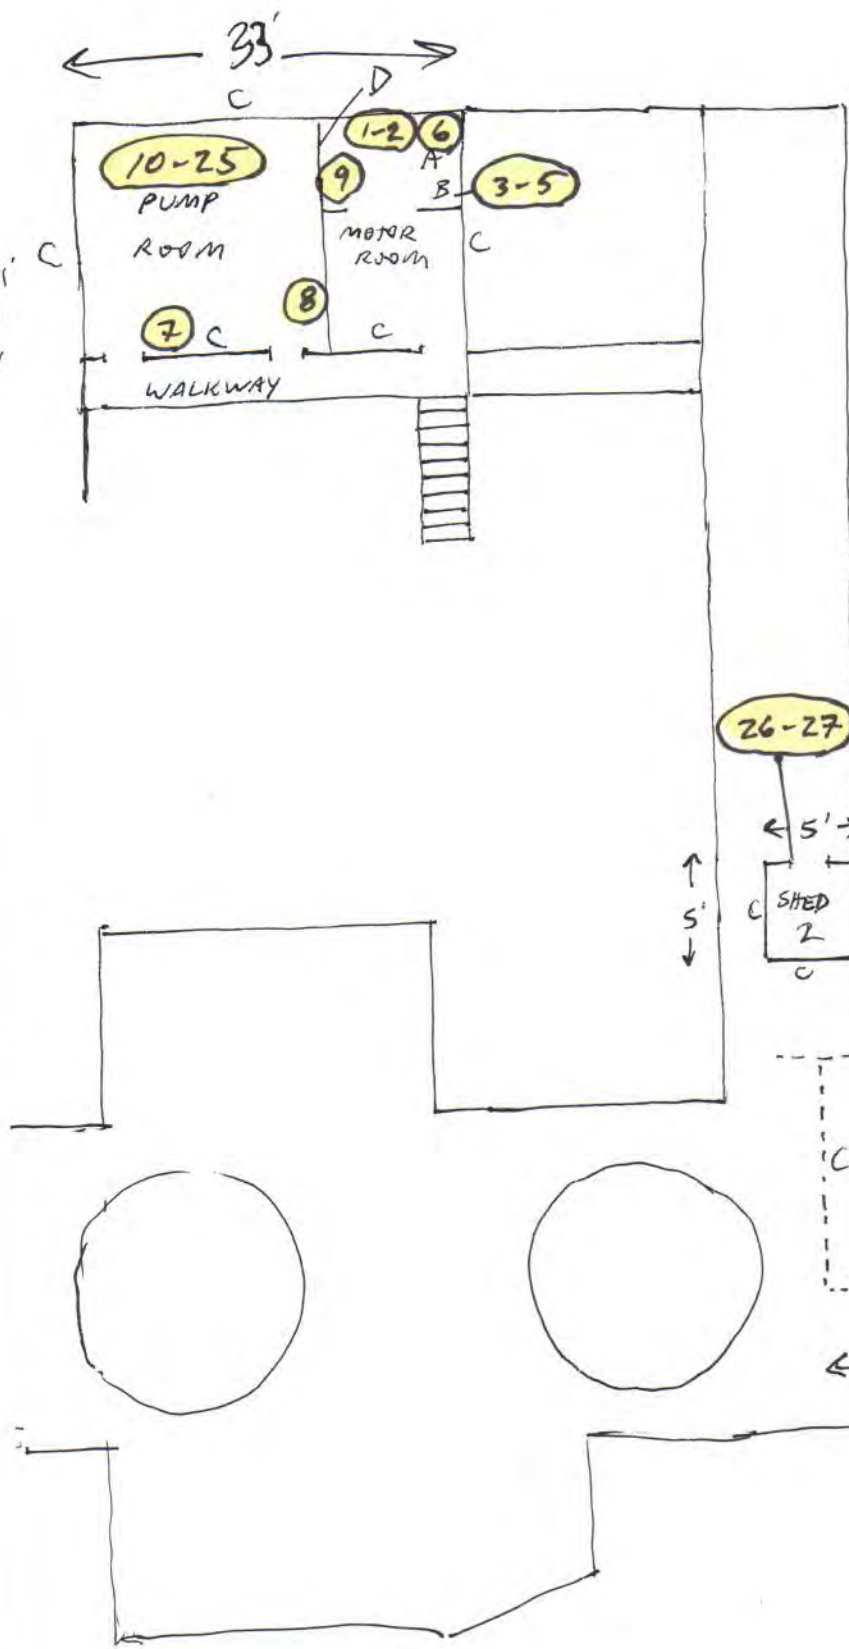
ASBESTOS SAMPLE LOCATIONS

- 1,2 A) BLACK/BROWN GASKET MATERIAL FAIR
- 3,4,5 B) WHITE FRIABLE ROPE GASKET
- 6,7 C) 20 LF POOR GRAY TRANSITE PANELS ROOF, WAHS
- 8,9,10 D) WHITE/GRAY WAH MUD POOR
- 11,12,13 E) WHITE 4" O.D. TSI (YELLOW) POOR
- 14,15,16 F) 30 LF POOR WHITE 6" O.D. TSI (ORANGE)
- 17,18,19 G) 50 LF POOR WHITE 12" O.D. TSI (ORANGE)
- 20,21,22 H) 30 LF POOR WHITE TANK INSULATION (ORANGE)
- 23,24,25 I) 3 TANKS - 75 SF WHITE 3" TSI (SILVER)
- 26,27 J) 50 LF POOR WHITE EXTERIOR DOOR CAULK
