CITY OF RICHMOND CITY AUDITOR

Audit Report# 2020-11

Department of Public Works Heat Scarification Contract March 2, 2020

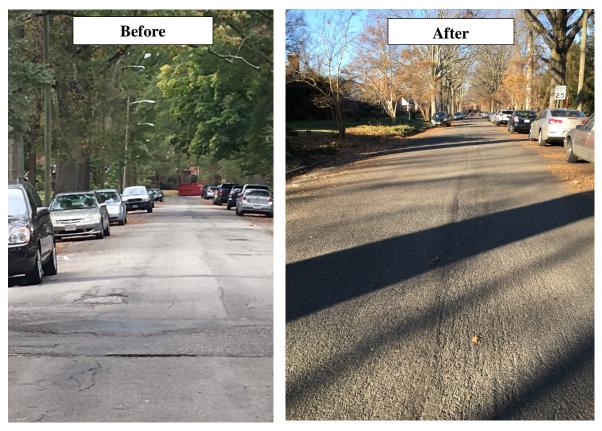
Below are photos of roads before and after treatment.

Whitby Road from Brook Road to Lamont Street

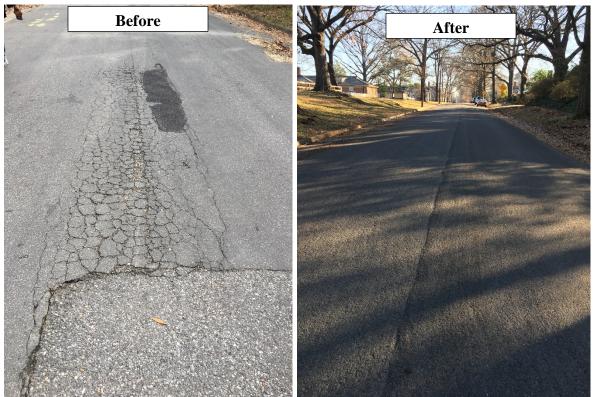
Rennie Avenue from Loxley Road to Brook Road

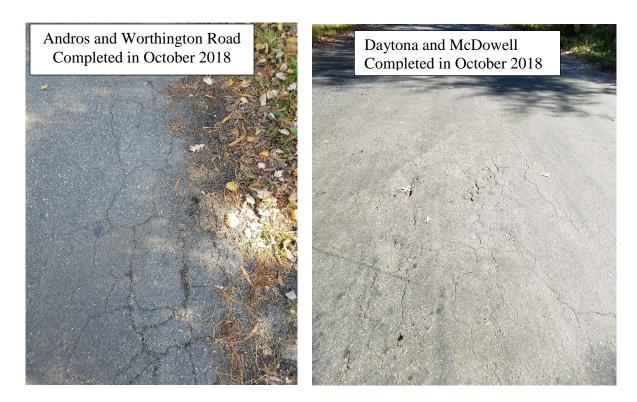
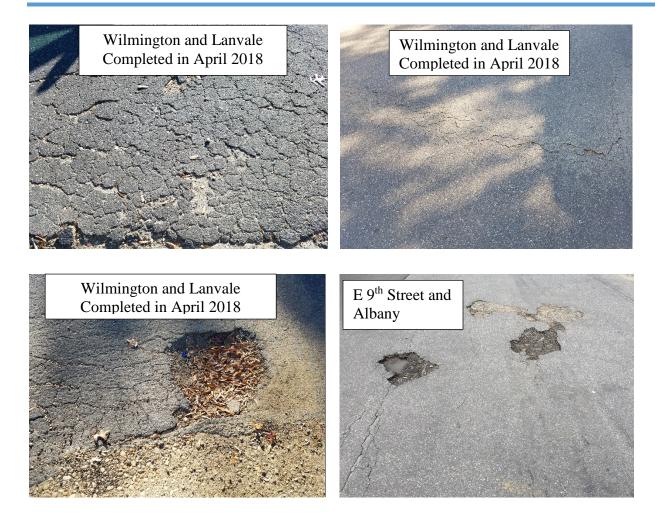
Approximately, 600,000 square yards of pavement was heat scarified between April 2018 and May 2019. The auditors visited 12 repair locations with heat scarification totaling 69,000 square yards and generally noted the repairs were in good condition. There were a few minor areas noted where the pavement is starting to fail as evidenced by potholes, unraveling pavement and

cracking. Based upon discussion with an independent professional who is knowledgeable about the heat scarification process, it was noted that the identified pavement failures could be structural and/or sub-surface related or the road may have had an insufficient asphalt base, which was not detected prior to the heat scarification process.

Below are sample photos of the noted pavement defects.

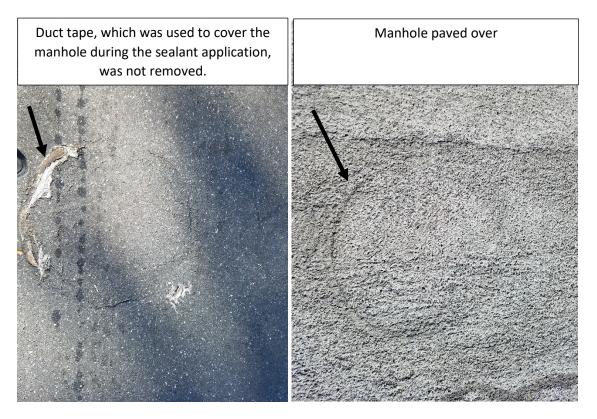
In addition to the minor pavement failures identified, the auditors observed that at least one manhole/utility cover was paved over for 67% (8/12) of the visited sites. Per the Project Manager, the covers were paved over when the sealant was applied to the roads, which is performed under a different contract. Although, this observation is outside of the contract under review, a risk still exists that individuals may not be able to easily locate and access the utilities when needed, which could cause a public safety issue during an emergency. The pavement inspectors are responsible for ensuring the manhole and utility covers are not paved over.

The following are sample photos of the covered manholes.

5. We recommend that the Capital Project Manager Senior and Pavement Inspectors ensure the contractor cleans off the utility and manhole covers prior to issuing payment.

#	RECOMMENDATION	CONCUR Y/N	ACTION STEPS
5	We recommend that the Capital Project Manager Senior and Pavement Inspectors ensure the contractor cleans off the utility and manhole covers prior to issuing payment.	Y	Once a city street is complete the inspection staff will go back and inspect for all utility castings to be free of and pavement.
	TITLE OF RESPONSIBLE PERSON		TARGET DATE
	Capital Project Manager Senior		2/24/2020
	IF IN PROGRESS, EXPLAIN ANY DELAYS		IF IMPLEMENTED, DETAILS OF IMPLEMENTATION
			Once a city street is complete the inspection staff will go back and inspect for all utility castings to be free of and pavement. If any utilities are covered the inspector will contact the contractor to have them uncovered.
